NACA RM E55H02

RESEARCH MEMORANDUM

FACTORS THAT AFFECT OPERATIONAL RELIABILITY
OF TURBOJET ENGINES

By Lewis Laboratory Staff

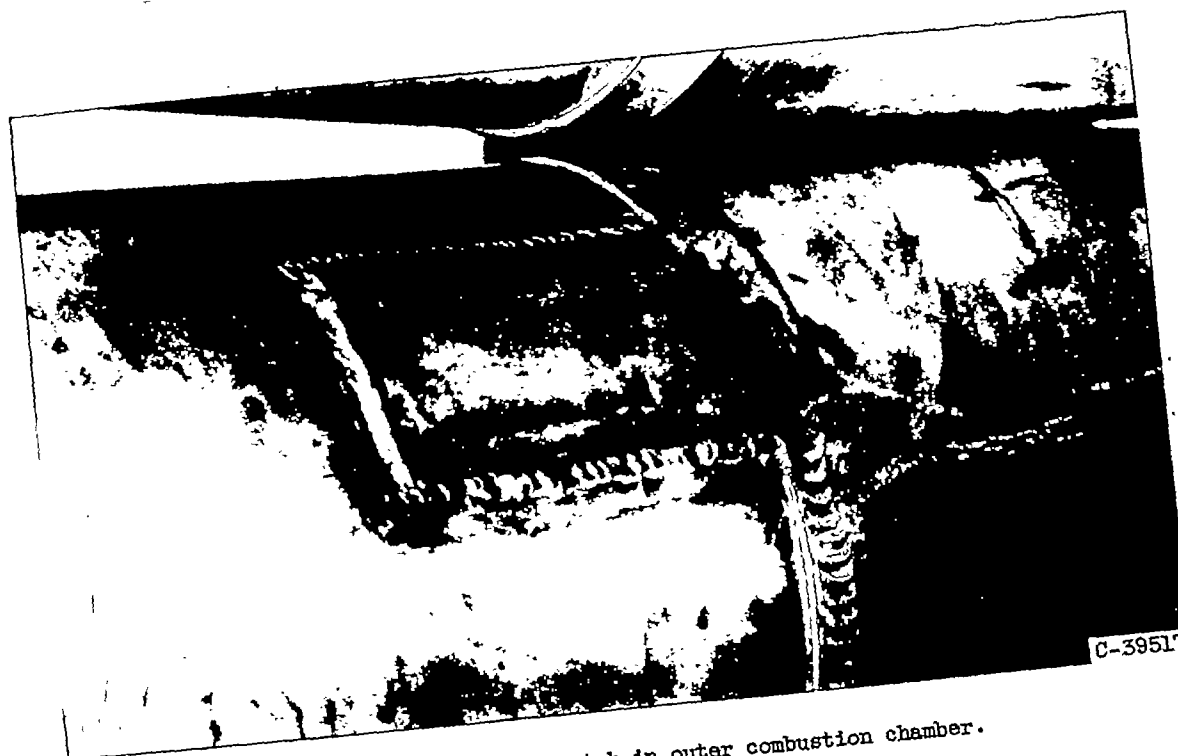
Figure 9. - Failure and patch in outer combustion chamber.

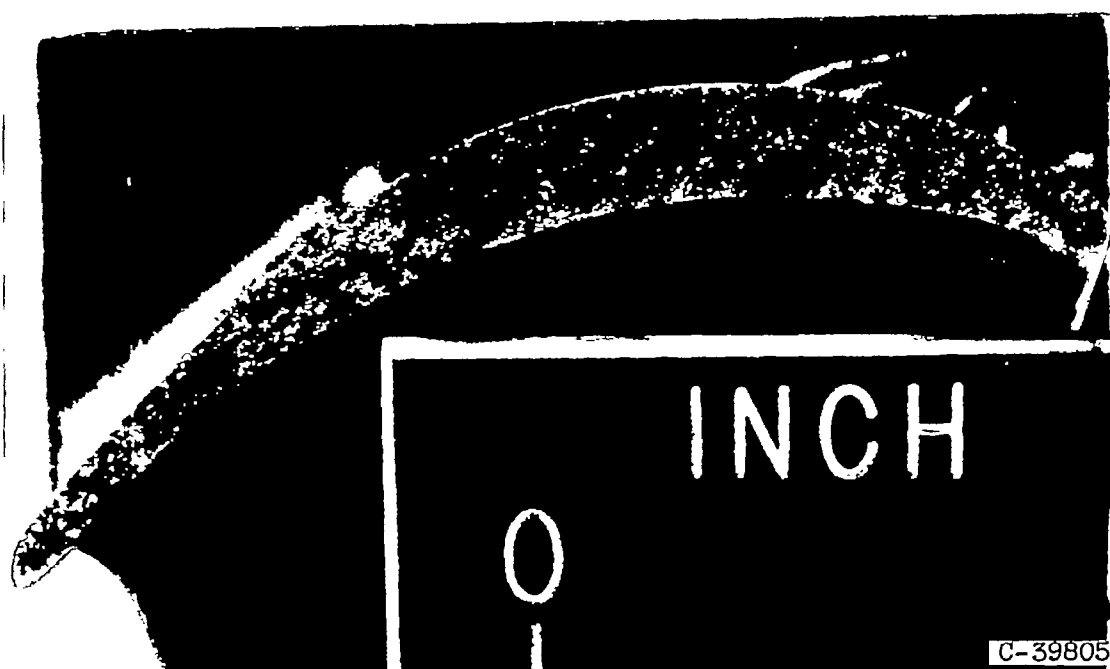
Intergranular cracking

Figure 6. - Typical stress-rupture fracture.

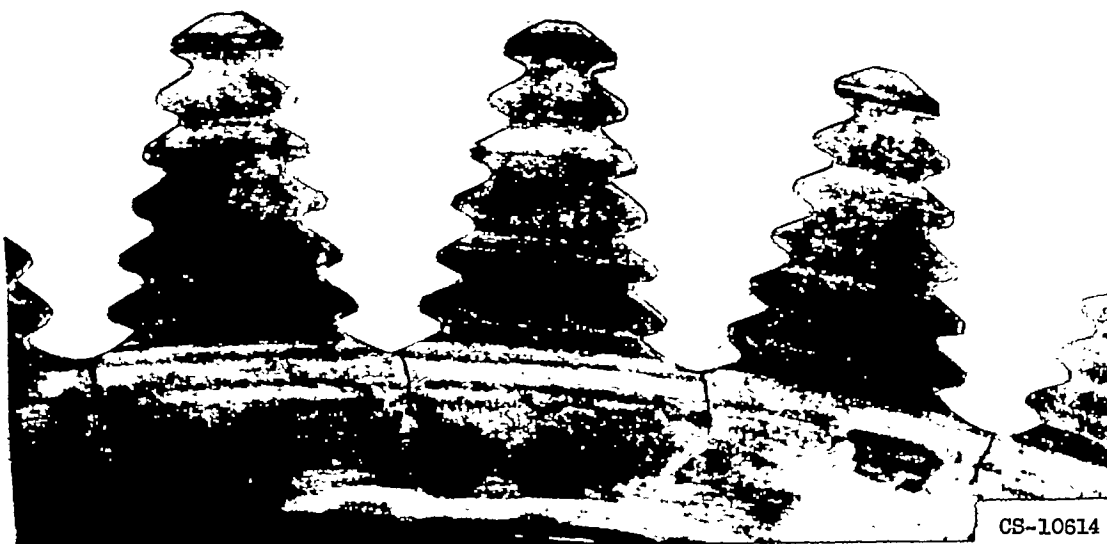
Figure 12. - Thermal-fatigue cracks.

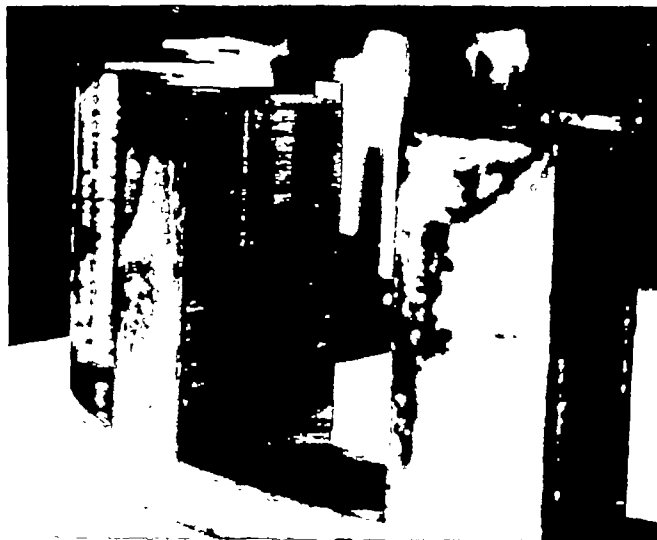
(a) Smearing on cylindrical rollers.

(b) Smearing on cage pockets.

(c) Smearing on outer raceway.

Figure 12. - Typical cylindrical roller bearing failure caused by inadequate lubrication between rollers and cage pockets. (From ref. 15.)

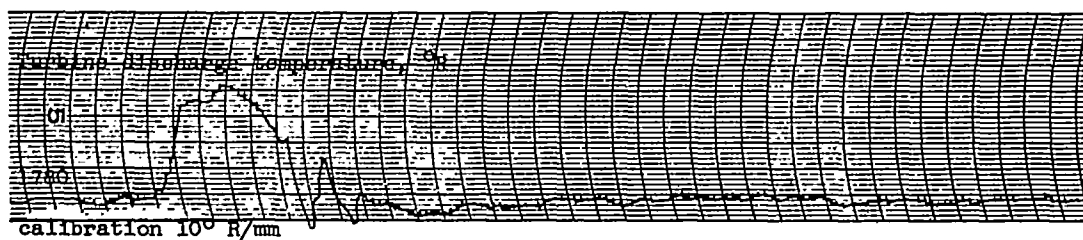
Figure 6. - Overtemperature incurred during ignition of afterburner; temperature controlled by variation of discharge nozzle area.
